Copper-assisted stress-corrosion cracking of stainless steel steam mesh

J. Stoulil*, V. Šeřl, J. Bystrianský

Abstract

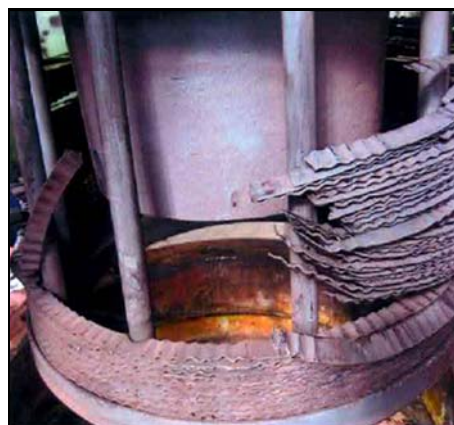
Fig. 1. An image of the damaged separator.

This study deals with a relatively new case of steam mesh (separator) cracking. Five cases of steam separator cracking (Fig. 1) and one case of cracked steam turbine baffle plate were reported. All defects occurred

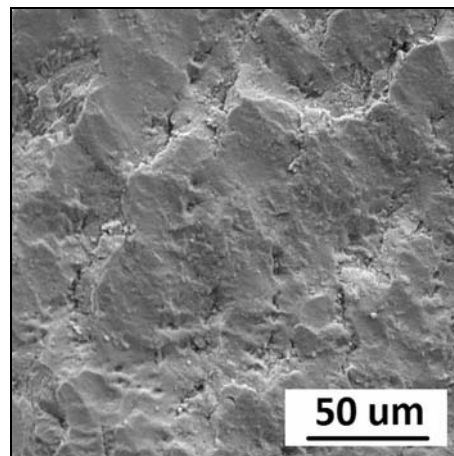
The fracture surface and the surface oxide morphology were studied first by SEM. The fracture surface corresponded to an intergranular fracture (Fig. 2), and the crack visibly copies borderlines of the material grains. When compared with energy dispersive X-ray analysis (EDS), the fracture surface did not contain any statistically more notable content of copper than the remaining surface. The surface morphology of the oxide layer is very rough (Fig. 3). However, oxides in the inner layer are compact and no massive oxidation was observed along the grain boundaries going inside the material, as can be seen on the metallographic

Fig. 2. SEM image of the fracture area.

The temperature is too low; therefore the impact of liquid metal embrittlement is very unlikely. The most probable corrosion mechanism is localised cracking of the defective oxide layer as a result of mechanical stress. Even though no elevated content of copper was identified on the fracture area, the negative im-

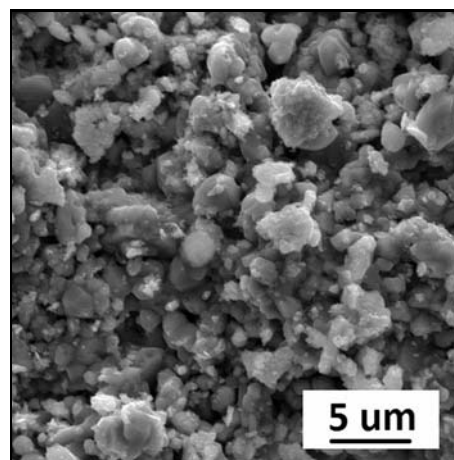
Fig. 3. SEM image of the surface oxide morphology.

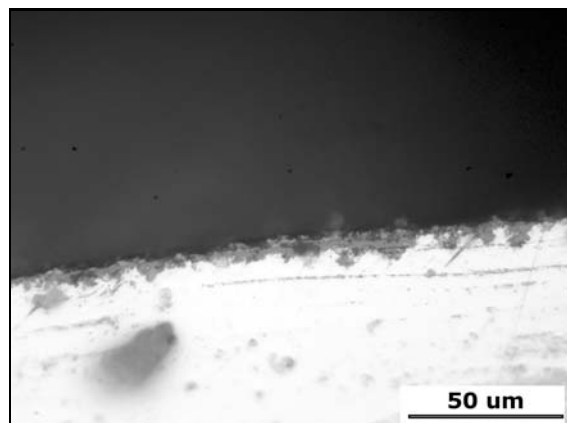
Fig. 4. Metallographic section of the specimen cross-cut.

section in Fig. 4. The thickness of the oxide layer is approximately 14 μm.

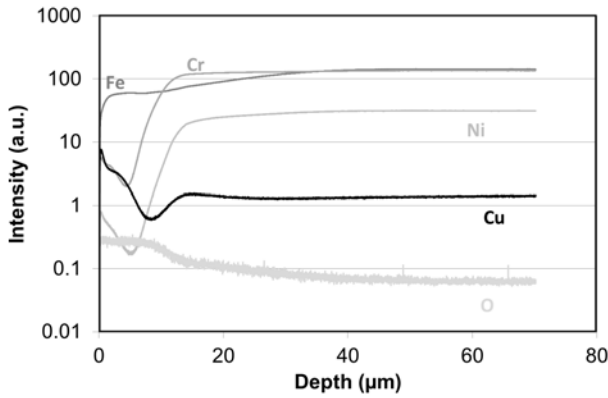
Fig. 5. GD-OES profile of chemical composition of the surface.

Glow discharge optical emission spectroscopy (GD-OES) was used in order to identify the in-depth element profile (Fig. 5). In contrast to other elements, copper is significantly enriched in the layer of oxides. When compared to the content in steel, the enrichment is already apparent at the metal/oxide interface, and is even more significant in the layer of oxides.

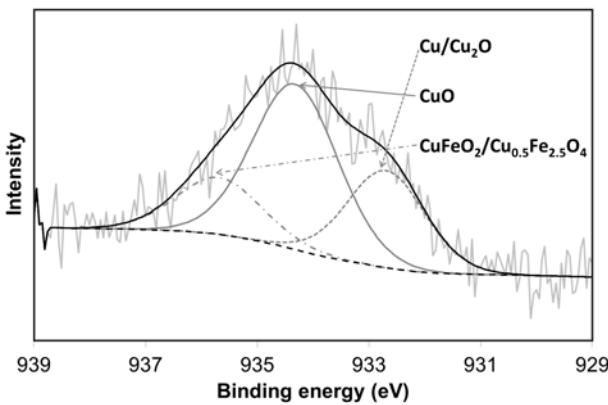
Fig. 6. The specimen’s XPS spectrum at a depth of 2 μm.

Oxidation states of copper were studied by X-ray photoelectron spectroscopy (XPS). An argon beam was used to sputter 2 μm from the oxide layer. The Cu 2p_{3/2} peak spectrum is shown in Fig. 6. The spectrum was fitted with the estimated full width at half the maximum level of 1.5 eV. There are three obvious peaks in the spectrum: 932.6 eV – metallic copper and cuprite (Cu₂O), 934.3 eV – tenorite (CuO), and 935.7 eV – mixture of Cu oxides with other metals.

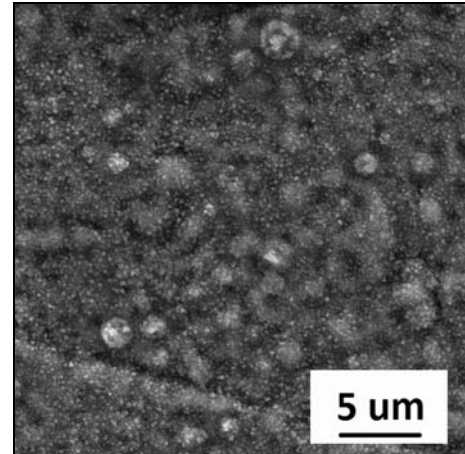
Fig. 7. SEM image of the sample FeCr18Ni10Cu.4 exposed in a model environment for 500 h.

A thin layer of the oxide FeCr18Ni10Cu.4 after the 500 h exposure is seen in Fig. 7. The oxides after the ‘model’ exposure have a finer structure compared to after the ‘real conditions’ exposure. When the content of copper in the material is elevated (FeCr18Ni10Cu3), delamination of the oxide layer oc-

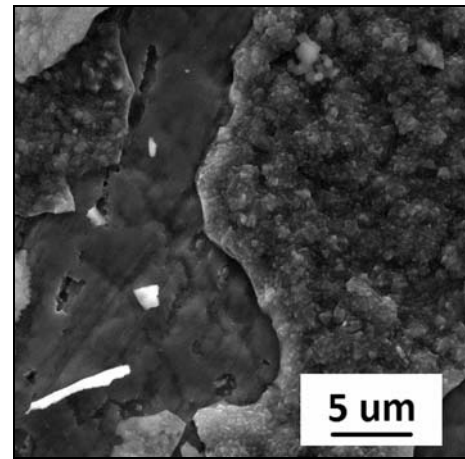
Fig. 8. SEM image of the sample FeCr18Ni10Cu3 exposed in a model environment for 500 h.

curs during the 500 h model exposure (Fig. 8). The copper concentration profile in the material beneath the oxide layer is shown in Fig. 9. A copper-depleted zone can be found below the oxide/metal interface after the 5 h exposure. After 50 h, the concentration is balanced and corresponds to the ‘real conditions’ exposure after 5000 h at 540 °C. In all cases, copper enrichment in the oxide layer was notably lower than in the ‘real conditions’ exposure. No significant copper segregation at the oxide/metal interface was detected in any of the model cases.

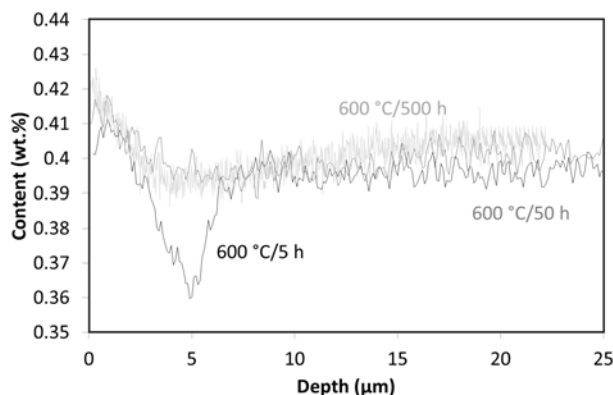
Fig. 9. GD-OES profile of copper under the oxide/metal interface.
