# The influence of the post-weld heat treatment on the microstructure of Mangalloy – carbon steel clad-plate obtained by explosive welding

R. Kosturek<sup>1</sup>, L. Śnieżek<sup>1</sup>, A. Maranda<sup>2</sup>, M. Wachowski<sup>1\*</sup>, J. Mierzyński<sup>1</sup>, K. Grzelak<sup>1</sup>

#### Abstract

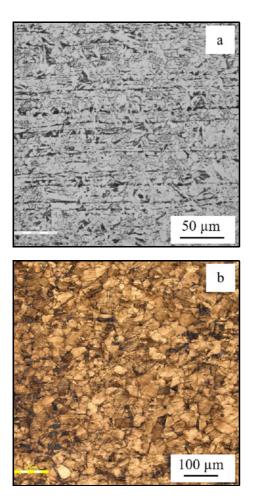
Fig. 2. Microstructure of materials in the as-received state:
(a) steel C45; (b) Mangalloy.

In the first part of the investigation, the light microscopy observations of the base materials were performed. The microstructures of steel C45 (Fig. 2a) and Mangalloy (Fig. 2b) in the as-received state are presented in Fig. 2. Steel C45 microstructure consists of ferrite, pearlite bands, and fine dispersion of spheroid cementite. Mangalloy has an austenite microstructure characterized by the occurrence of twins. The micro-

hardness of base materials was measured with registered values of 154.3  $\pm$  4.2 HV0.1 for steel C45 and 220.2  $\pm$  3.6 HV0.1 for Mangallov.

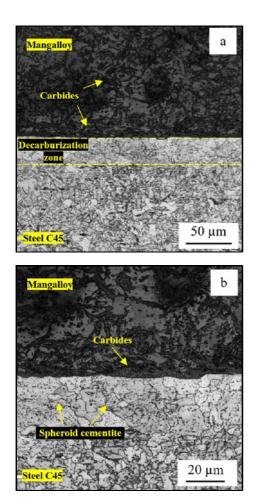
Fig. 4. The microstructure of the joint in sample A3 HTR:(a) joint line with decarburization zone;(b) spheroid cementite in decarburization zone.

in the joint line area. As it can be observed (Fig. 4a), the performed annealing process resulted in the formation of carbide precipitates at the grain boundaries of Mangalloy. A worth noting phenomenon is a high concentration of carbides on the joint line (Fig. 4b). At the same time, the presence of a pearlite-free decarburization zone in C45 steel indicates the diffusion of carbon from C45 steel into Mangalloy due to performed heat treatment, which promotes the formation of carbides localized on the joint line. The width of the pearlite-free zone is about  $30 \,\mu m$ . The only highcarbon concentration residue is the spheroid cementite (Fig. 4b). Additionally, the significant grain growth of steel C45 has been reported in the decarburization zone of the A3 HTR sample. Steel C45 grains localized on the joint line do not have a deformation texture, and their size is about 15–20 µm.

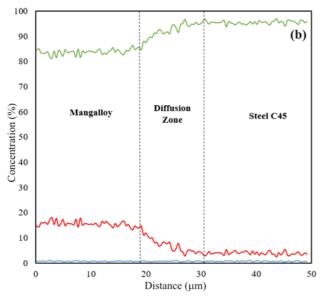
Fig. 6. The microstructure of the joint in sample A3 HTN:(a) distribution of alloying elements in the joint zone;(b) results of the line scan analysis (white marker): iron (green), manganese (red), carbon (blue).

distribution of alloying elements (Fig. 6a) and line scan through joint line (Fig. 6b), indicates the diffusional character of the transitional zone (Fig. 5b). Based on the lines scan results, it is possible to estimate the width of the diffusion zone as about  $10\,\mu m$ .

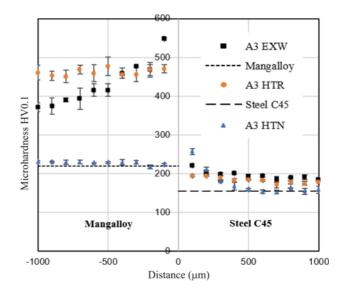
Fig. 7. The results of microhardness analysis.

The observed joint zone microstructure in all samples finds their reflection in the results of microhardness analysis (Fig. 7). In case of the joint in the as-welded state, there is the increase in microhardness in the joint zone; it has been reported that the most significant hardening, about 470 HV0.1 (increase from 220 HV0.1 to 690 HV0.1) is related to Mangalloy which high strain hardening rate is caused by deformation twinning. The effect of the collision on Mangalloy hardness is noteworthy even in 1000  $\mu m$  from the joint line. A similar level of Mangalloy microhardness at the joint line (725 HV0.1) has been reported in the investigation in which 3200 m s $^{-1}$  detonation velocity was used [21].

Although the explosive hardening of Mangalloy is used in the industry, the obtained level of hardening is significantly lower [22]. This can be explained by the higher value of pressure during the collision of metal plates accelerated by detonation than in the case of the direct affecting metal plate by detonating explosive material [23]. For steel C45, the observed hardening in the joint zone does not have such a drastic increase (an increase from 154 HV0.1 to 265 HV0.1). Although stress relief annealing slightly decreases hardness of both materials in the area closest to the weld interface and equalizes the strain hardening of steel C45, it also causes the formation of carbides in Mangallov (Fig. 4a) which results in the high value of hardness (about 470 HV0.1) uniformly distributed in the joint zone. Clad-plate subjected to normalizing heat treatment undergoes noticeable softening. Mangalloy recrystallization decreases the hardness of clad material to its pre-welded state (about 220 HV0.1) without the formation of carbides due to the shorter time of the annealing. Also, at the distance of 400  $\mu m$  from the joint line, the microhardness of base material has returned to its pre-welded state (about 154 HV0.1). The only reported fluctuation in the distribution of welded materials microhardness is related to the dissolution of cementite with the formation of pearlite grains in the steel C45 layer, mostly noticeable at a distance 200  $\mu m$  from the joint line (Fig. 5b). This phenomenon causes an increase of microhardness in this area due to the formation of ferrite-pearlite microstructure, which does not allow to obtain a pre-weld microhardness value of base material.
